Safety Harness Prevents Fall to Ground

When Worker Steps onto Skylight

*3rd Annual BlueDragon Users Group Meeting
December 17, 2020*

BROOKHAVEN
NATIONAL LABORATORY

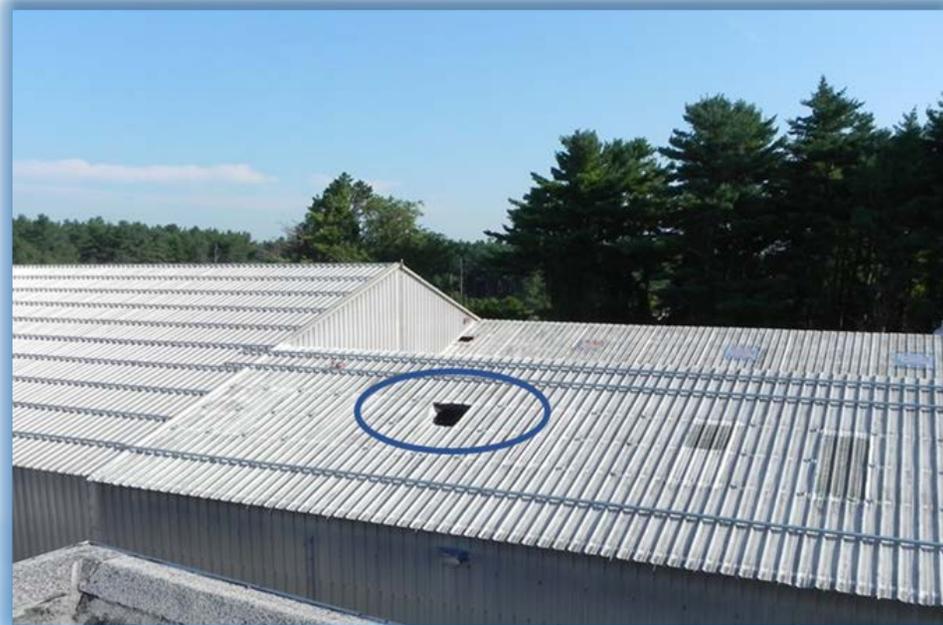
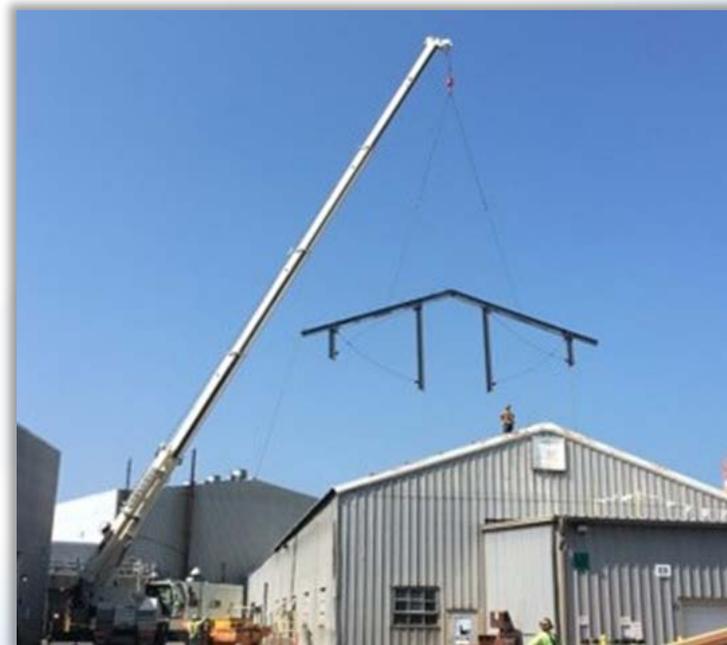
- **July 27, 2020:** As part of bldg. upgrades, a sub-contractor is installing steel roof trusses through openings cut in the existing roof
 - During the lift, an ironworker acting as spotter for the crane (standing on the roof) walks to grab a tag line and falls through a skylight
 - The worker is using a personal fall arrest system (PFAS) and there is no injury. The worker is able to self-rescue.

- **Root Cause:** The **work planning** process at multiple stages **did not identify the hazard** or addressed the risk posed by the skylights on a working/walking surface

- The work planning at all levels failed to identify the skylights as a fall hazard, and when it was identified in the field, the risk posed by it was not properly assessed, which resulted in LTA mitigation.
